Railroad Investigation Report RIR-24-05

Norfolk Southern Railway Derailment and Hazardous Materials Release

East Palestine, Ohio
February 3, 2023

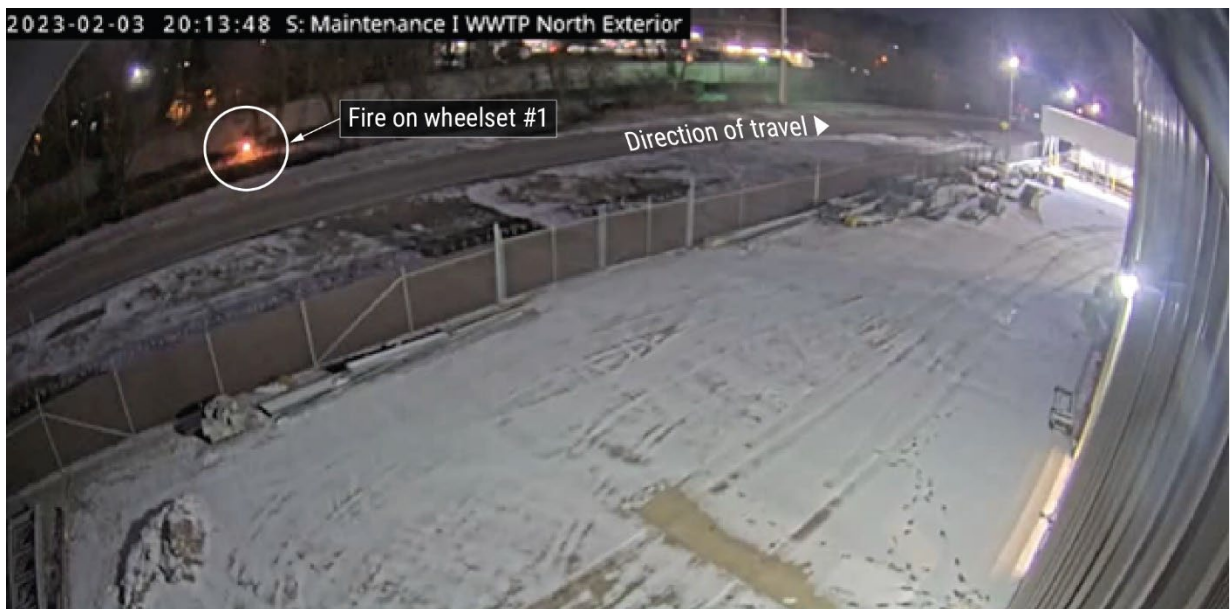
Between 8:11 p.m. and 8:14 p.m., train 32N passed four surveillance cameras in Salem, Ohio, that recorded images of the train. The images showed a fire on wheelset #1 of the hopper car. (See figure 5 for an image from a surveillance camera positioned on South Lincoln Avenue.) The images did not show signs of fire on other railcars.

Figure 5. Fire on wheelset #1 of the hopper car passing through Salem, Ohio.

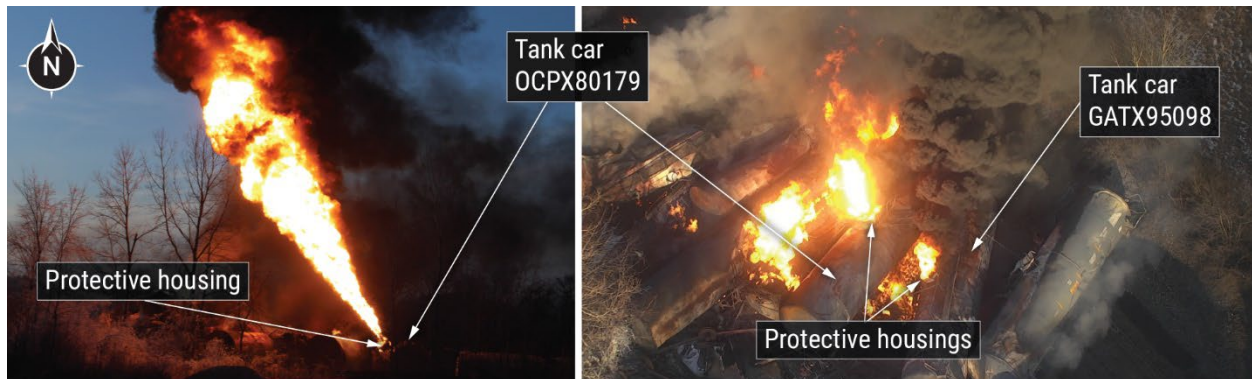
The first PRD actuation on a VCM tank car occurred shortly after midnight on February 4. A PRD actuates when the pressure inside a tank reaches the PRD's start-to-discharge pressure—a pressure high enough to open a valve held closed by a spring. The PRD opens until the tank's pressure falls low enough for the valve to re-close. A PRD on a tank car exposed to a pool fire will typically go through this cycle multiple times. PRD cycling continued for the four fire-exposed VCM tank cars until midafternoon on February 4, when the pool fires near four of the tanks had largely subsided. After 1.5-2 hours without visible PRD activity, the PRD on tank car OCPX80179 actuated about 5:30 p.m. and vented continuously for about 70 minutes. This venting was more energetic than other PRD actuations on the VCM tank cars. (See figure 8 for a comparison.) The PRD on tank car OCPX80179 eventually re-closed and did not actuate again. NS and contractor personnel did not observe any further PRD activity from the VCM tank cars.

Figure 8. PRDs venting material energetically (left) and more typically (right).

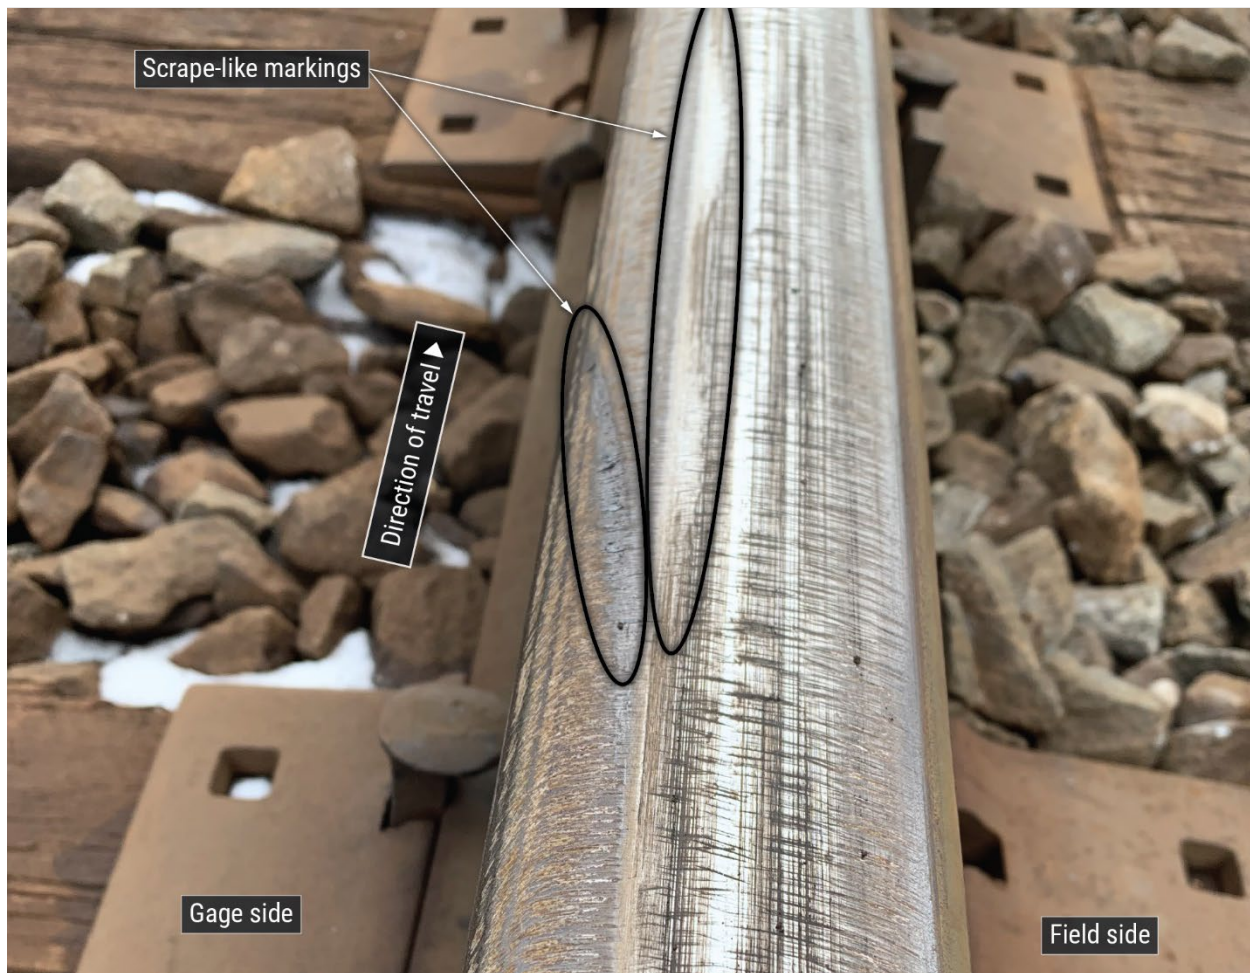
The grooves and markings on the rail were consistent with a point of derailment at MP 49.5.

Figure 11. South running rail at MP 49.5.

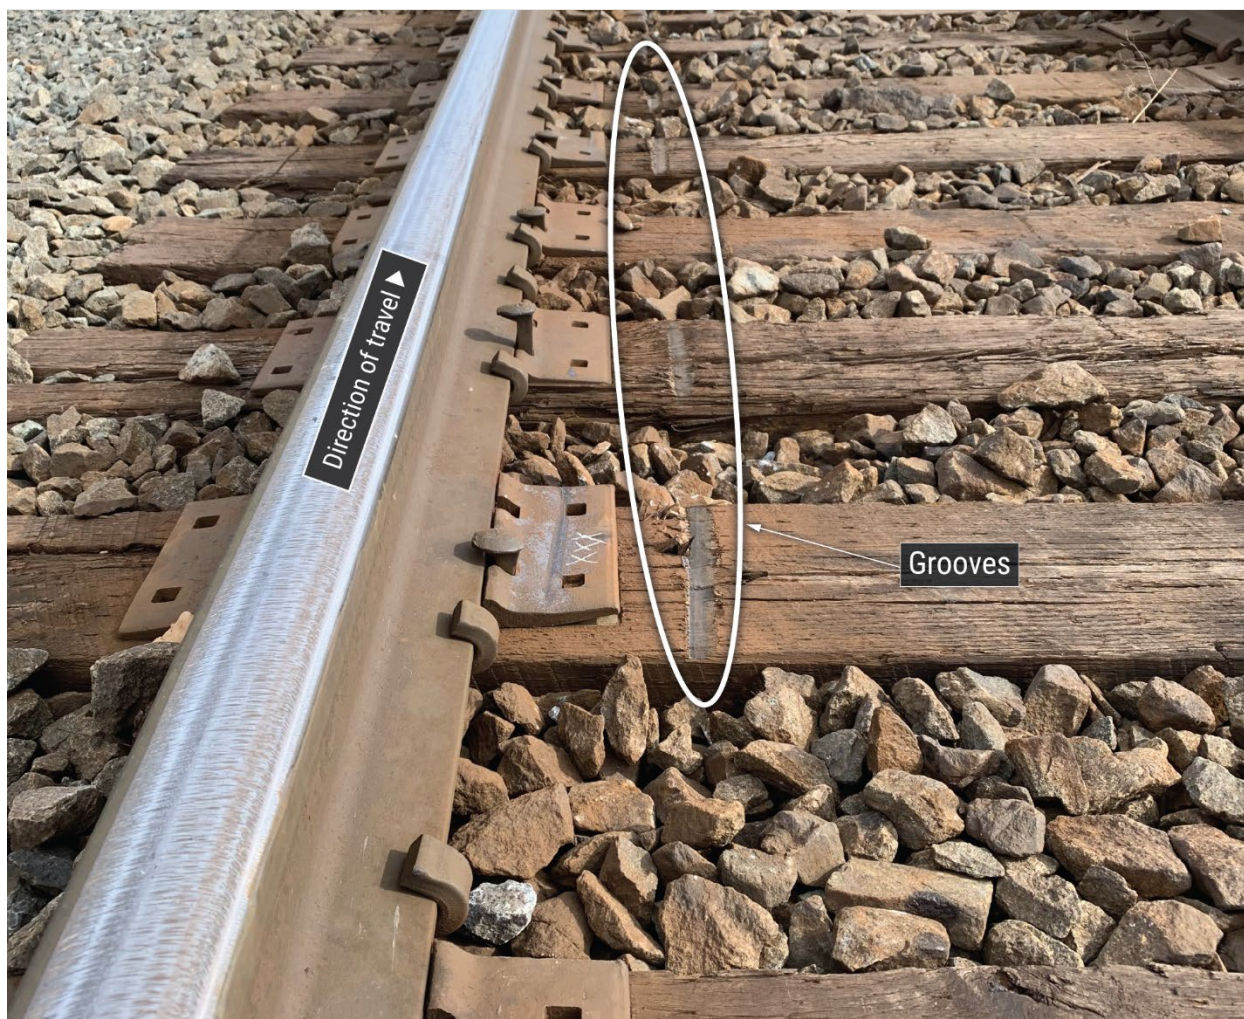
Figure 12. Wheel flange marks on cross-ties east of MP 49.5.

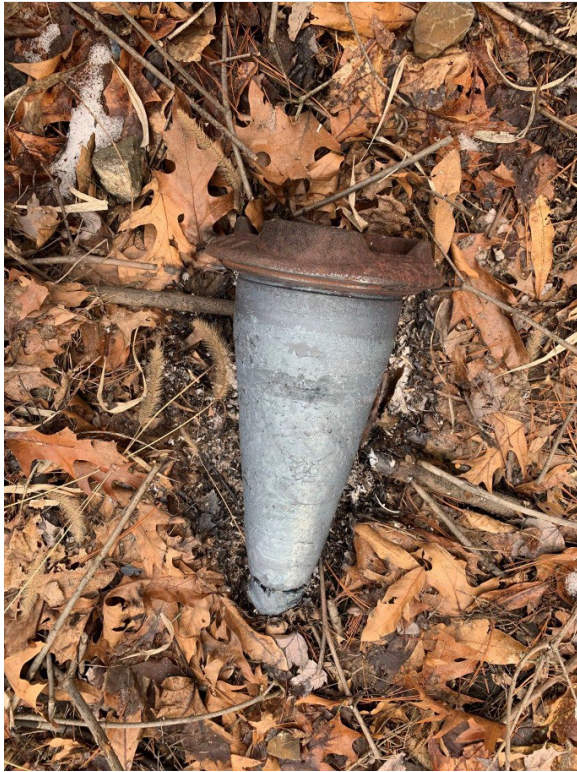
Figure 15. L1 journal as found on the scene.

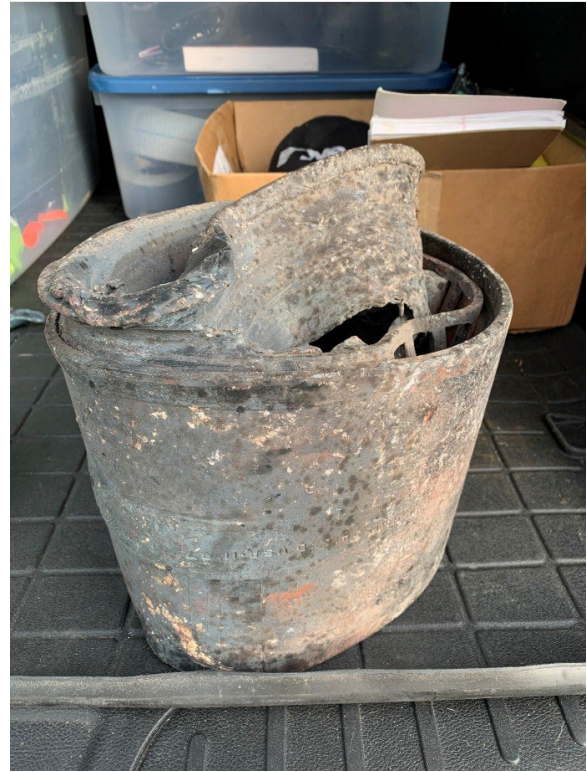
Figure 16. Other L1 bearing components post recovery.

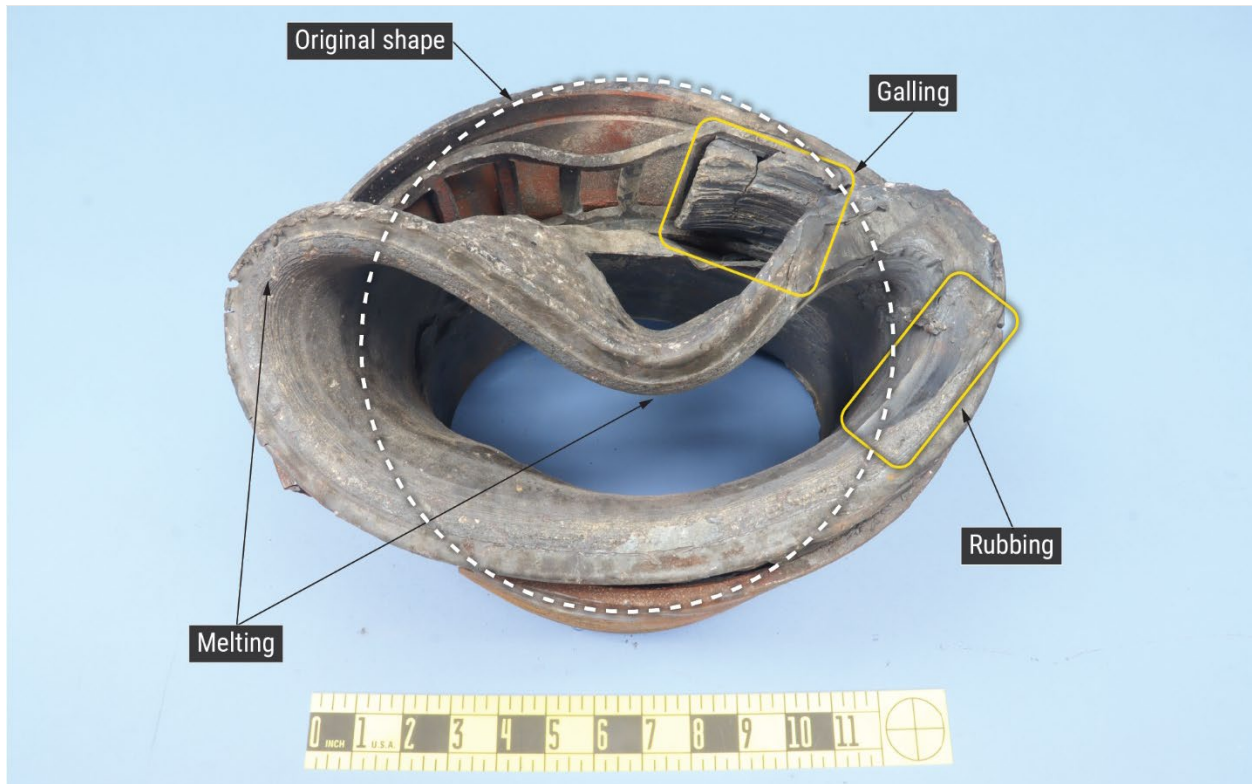
An NTSB contractor disassembled and documented these components in the presence of the NTSB and party members on April 11, 2023. Markings on the components indicated that the bearing had been reconditioned in June 2011.⁷⁷ The L1 bearing's polymer grease seals were missing, and its steel components had sustained extensive damage as shown in figure 18 and figure 19, including:

Figure 18. Recovered bearing cup and other components.

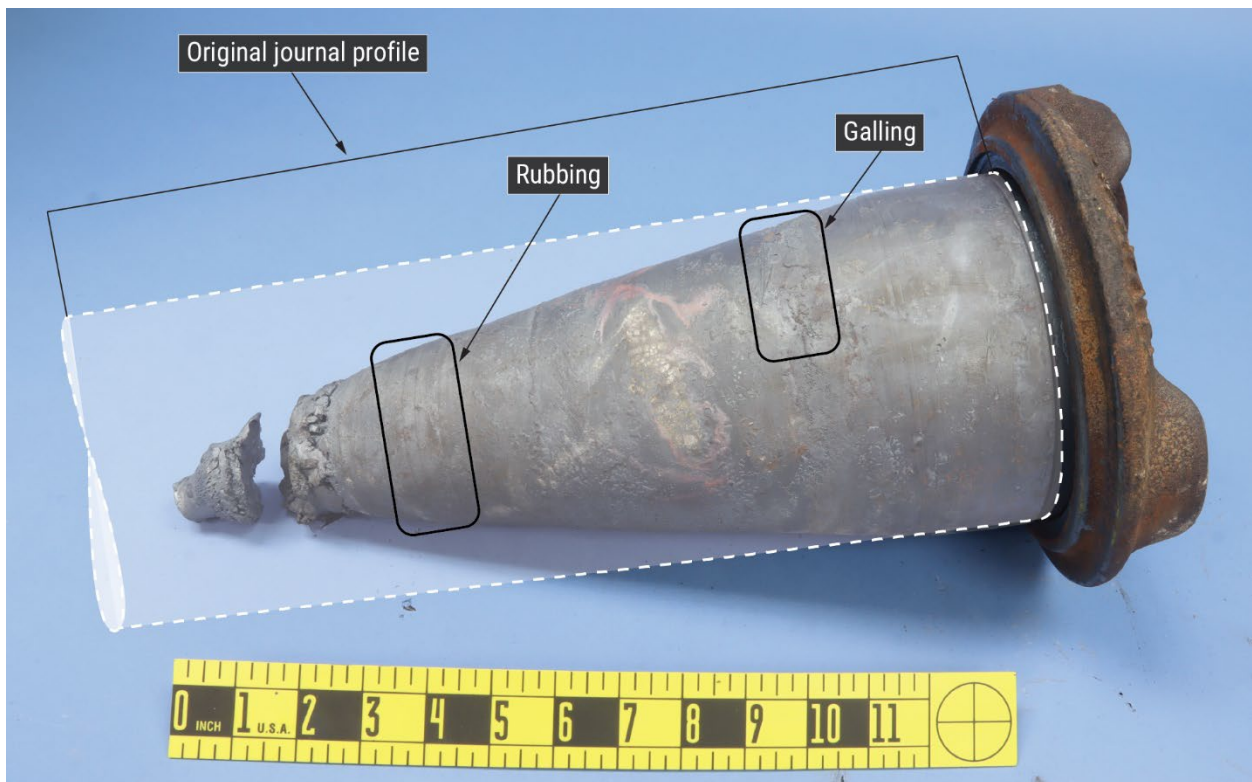
Figure 19. Recovered bearing journal.

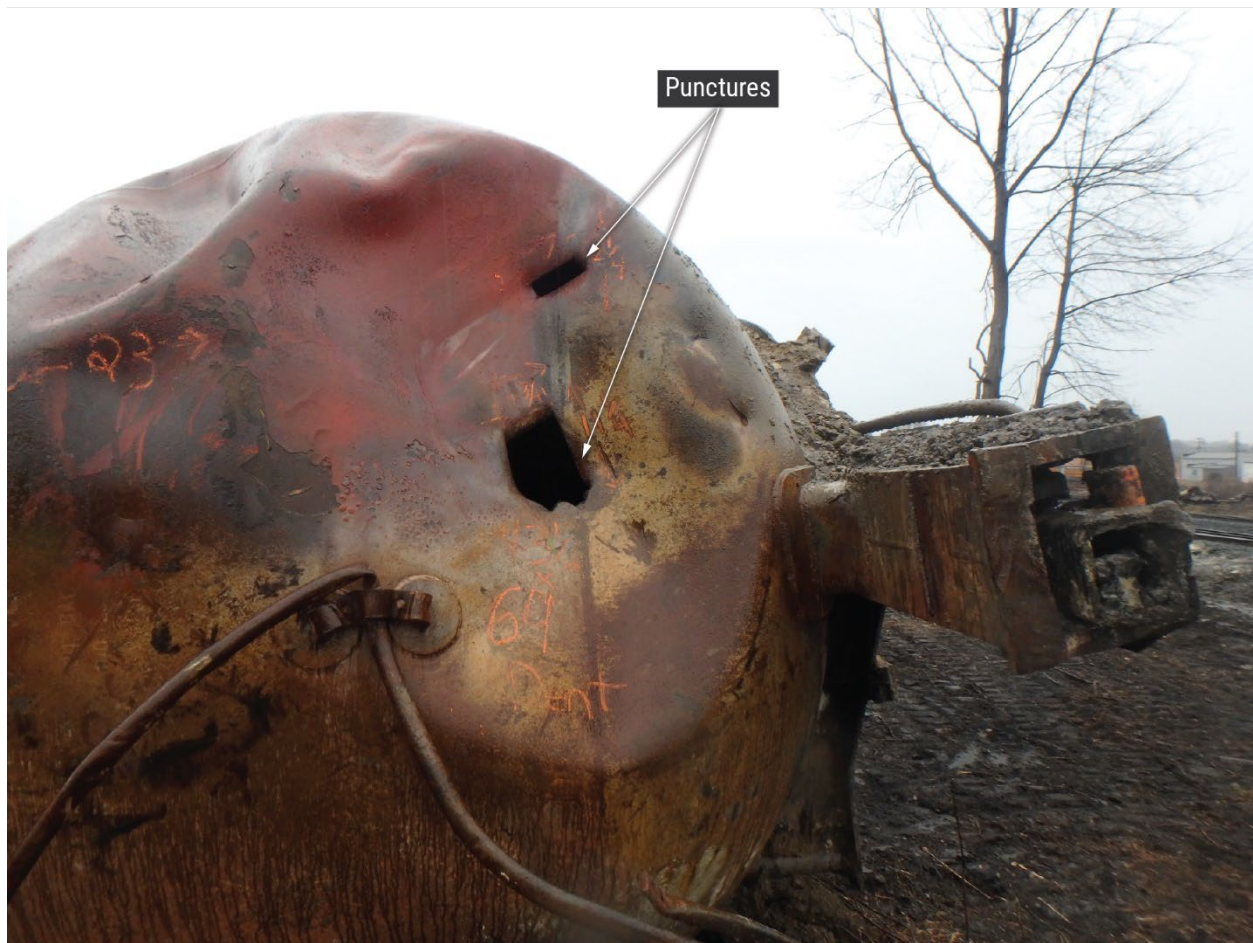
Figure 16 shows an example of tank head punctures sustained by a DOT-111 tank car, UTLX205907, which was constructed of non-normalized steel (which is less damage tolerant than normalized steel) and not equipped with a head shield.

Figure 20. Leading A-end head punctures on tank car UTLX205907.

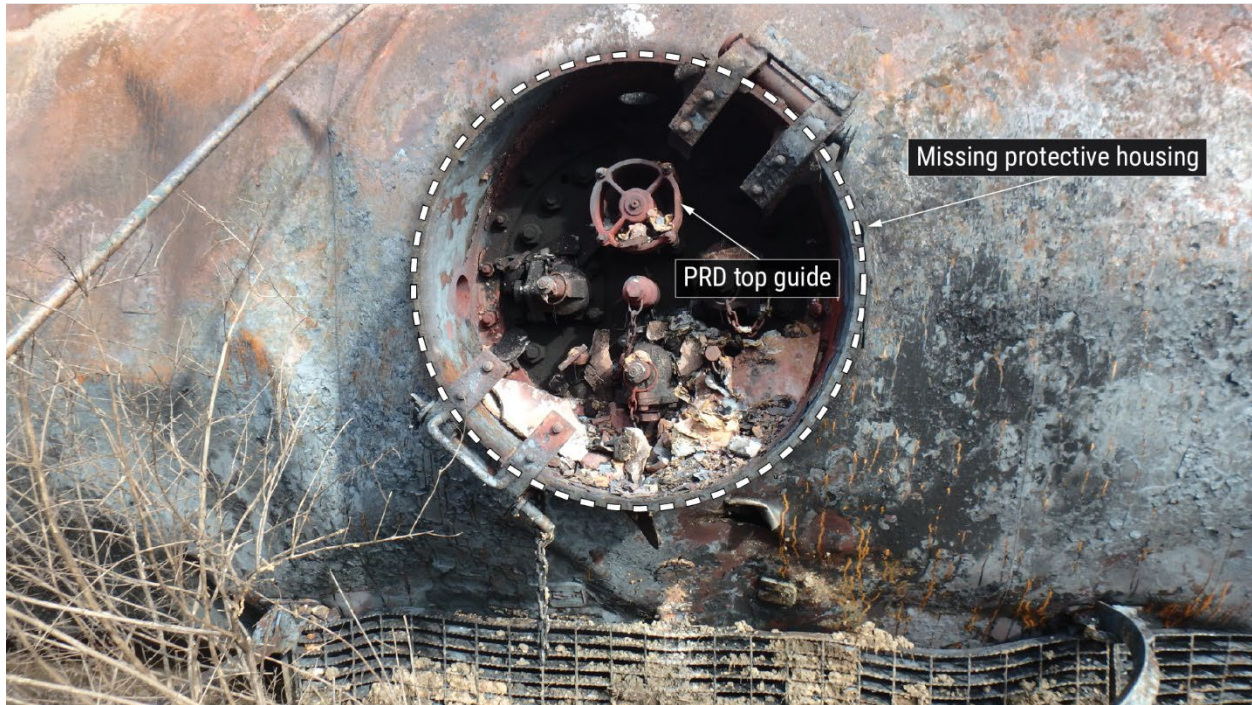
Figure 21. Tank car OCPX80235's protective housing with the aluminum cover missing.

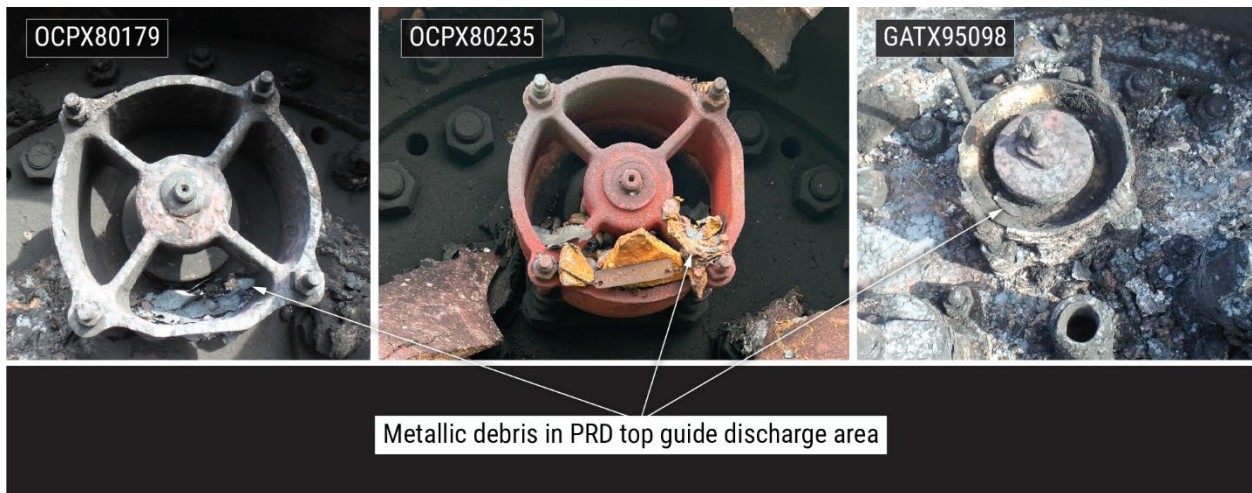
Figure 22. Metallic debris in the PRDs of tank cars equipped with aluminum protective housing covers.

Investigators collected samples of metallic debris and sent them to the NTSB Materials Laboratory in Washington, DC, for examination. After NS contractors removed pressure plates from all five VCM tank cars, the NTSB recovered the PRDs for bench testing at the Trinity Rail Maintenance Services Saginaw Plant in Saginaw,

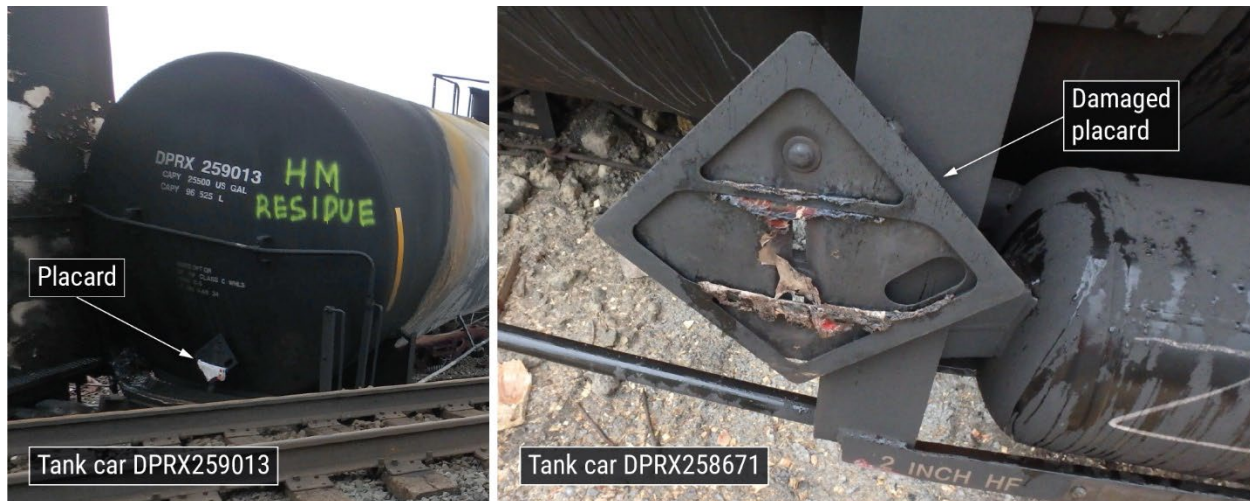
When interviewed by the NTSB, the EPFD deputy fire chief reported that the placards affixed to several railcars had sustained damage and became illegible after being exposed to heat. The NTSB photographed several damaged placards during its on-scene investigation. Figure 26 provides two examples.

Figure 26. Postderailment photographs of placards exposed to heat.

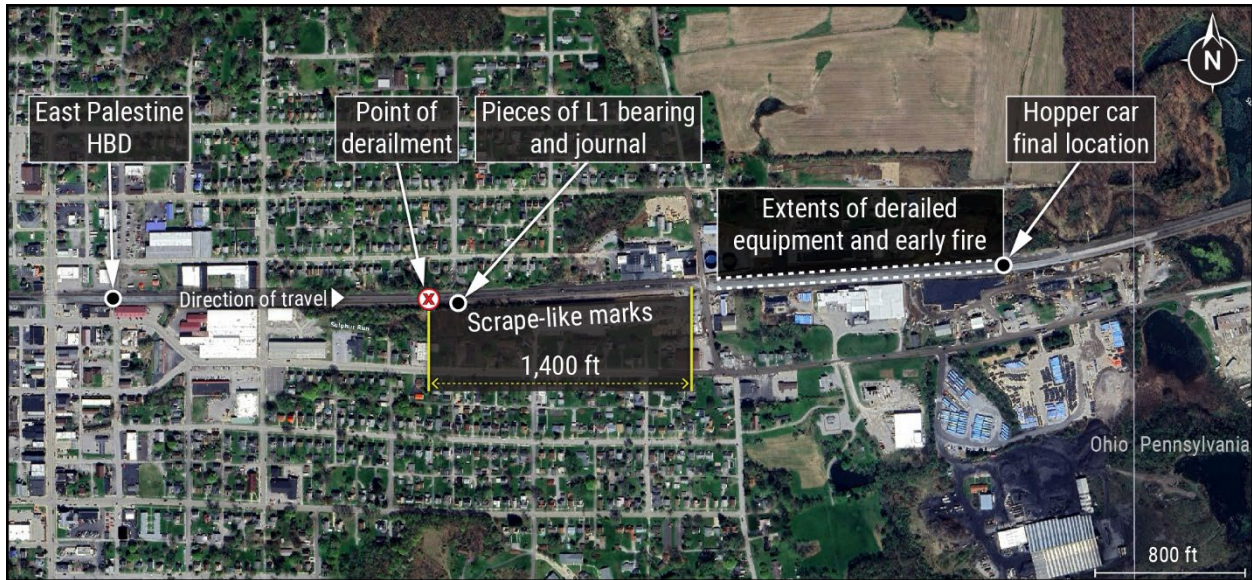
The NTSB recovered components from the L1 bearing and journal near the tracks west of the derailment pileup. (See figure 28.) The components’ positions west of the pileup and far from the rest of the wheelset indicate that they became separated from the hopper car in the earliest moments of the derailment, when the hopper car was still west of its final, postderailment location.

Figure 28. Locations of derailment evidence.

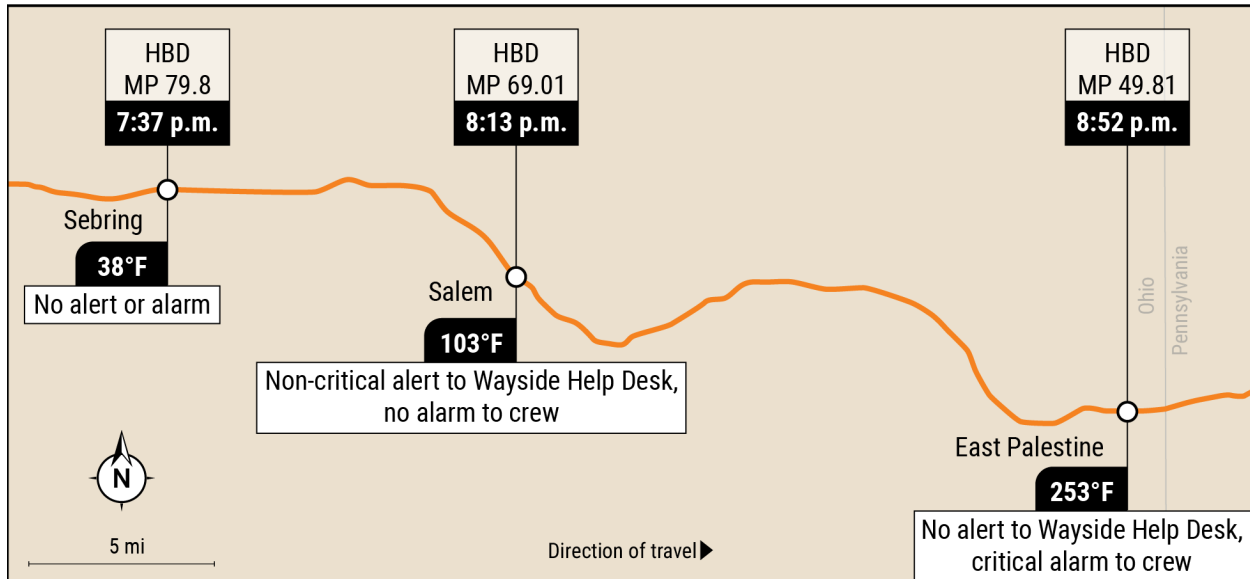
these detectors, located in Sebring, Ohio, and about 30 miles west of the derailment site, did not record any bearing temperatures high enough to trigger an alert or alarm. Surveillance cameras in Sebring, Ohio, captured images of the train, and no anomalies were noted in the images.

Figure 29. Summary of HBD temperature measurements, alerts, and alarms.

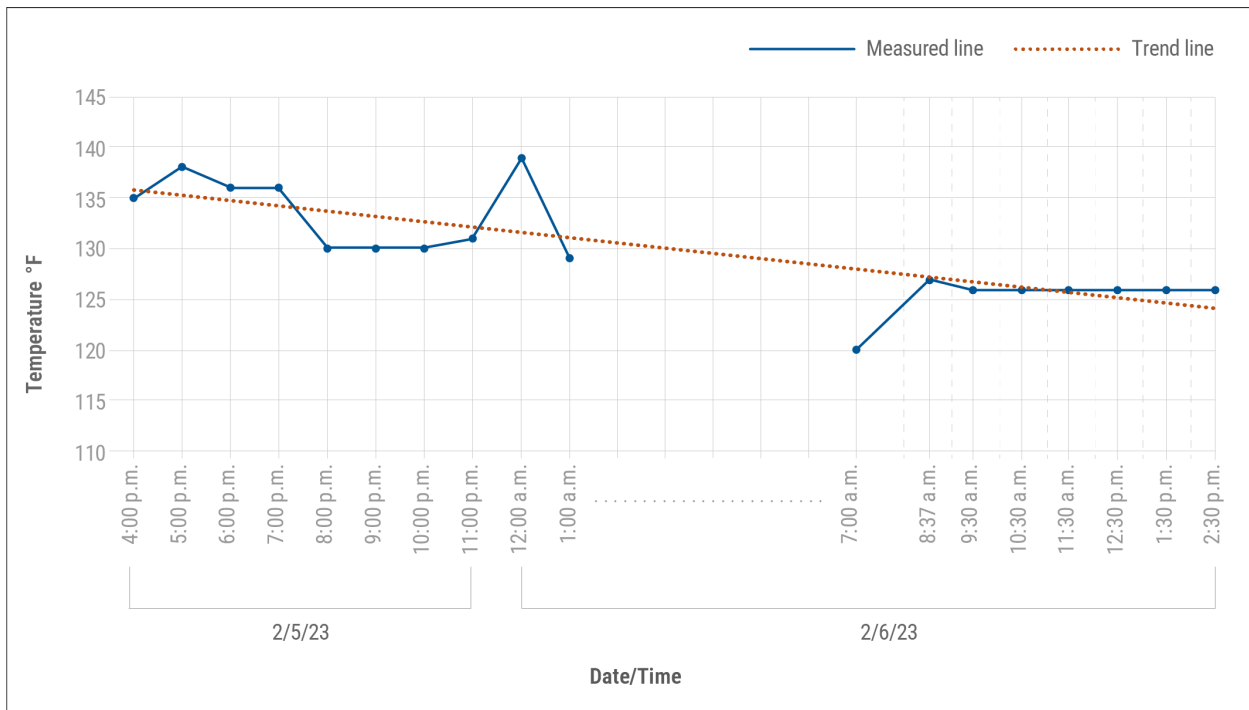
temperatures are listed in table 3. In discussions with the incident commander and the NTSB on scene, NS noted a 3°F increase in temperature for tank car OCPX80370 as an indication that polymerization was occurring. This increase to 138°F on the afternoon of February 5 was close to the highest temperature recorded on a tank car shell (139°F, measured during a brief fire under the tank car about midnight on February 5-6). Tank car OCPX80370 was the only tank car to show significant variations in temperature during monitoring.¹⁵⁴ The temperature for OCPX80370 is plotted in figure 31 (blue), along with a trendline (red).

Figure 31. Measured temperatures and trendline for OCPX80370.
