Railroad Investigation Report RIR-24-05

Norfolk Southern Railway Derailment and Hazardous Materials Release

East Palestine, Ohio
February 3, 2023

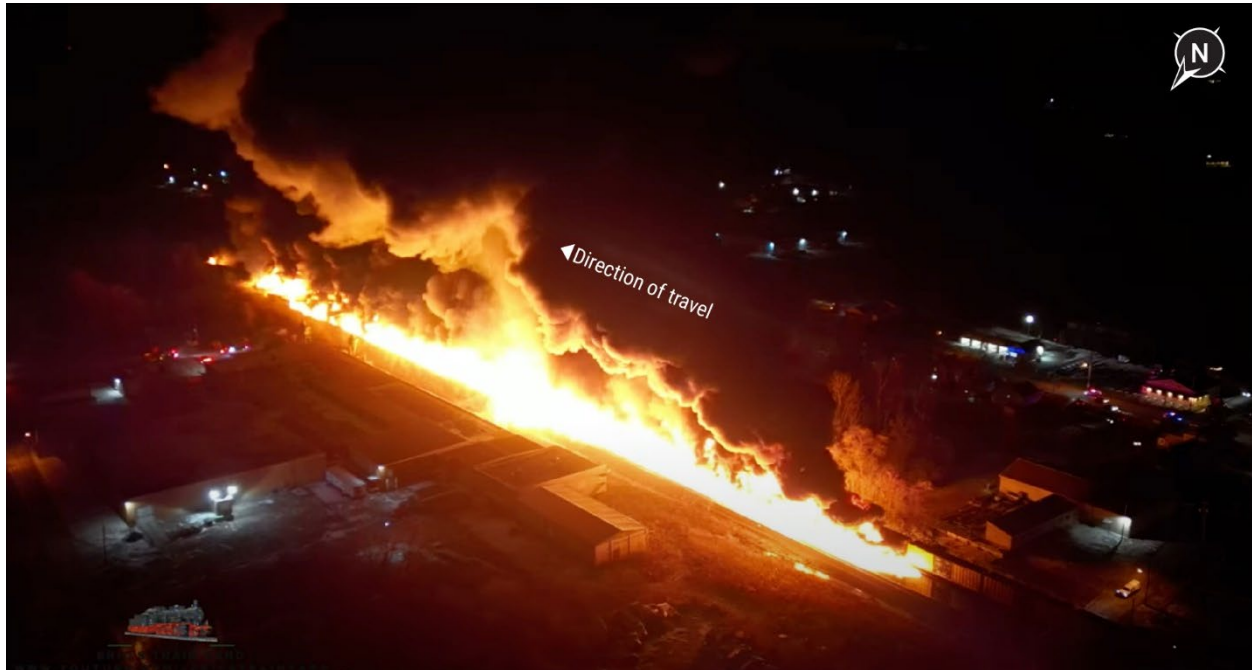
Figure 1. Overhead view of derailment and early fire. (Courtesy of Eric's Train Yard.)

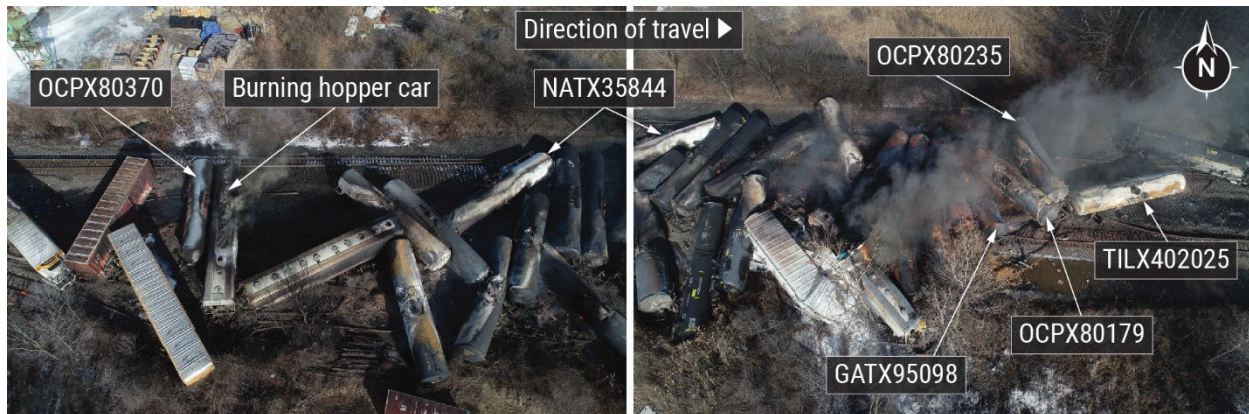
as “UN1055, isobutylene, 2.1.”³⁰ All six were United States Department of Transportation (USDOT) Specification DOT-105J300W tank cars, usually referred to as DOT-105 tank cars. The isobutylene tank car (NATX35844) was positioned near the middle of the derailment pileup. One VCM tank car, OCPX80370 (line 55 in the consist), was positioned near the western end of the derailment pileup, exposed to a pool fire, and resting against a burning hopper car containing plastic pellets. The other four VCM tank cars—TILX402025 (line 28), OCPX80235 (line 29), OCPX80179 (line 30), and GATX95098 (line 31)—were positioned near the eastern edge of the derailment pileup. (See figure 7.) Tank car TILX402025 had come to rest between the two main tracks and was not directly exposed to a pool fire. Aerial images showed that the cover over the protective housing on TILX402025 remained closed during this period.³¹ The other three VCM tank cars at the eastern edge of the pileup were grouped together and exposed to postderailment fires.

Figure 7. Derailment pileup and VCM tank cars.

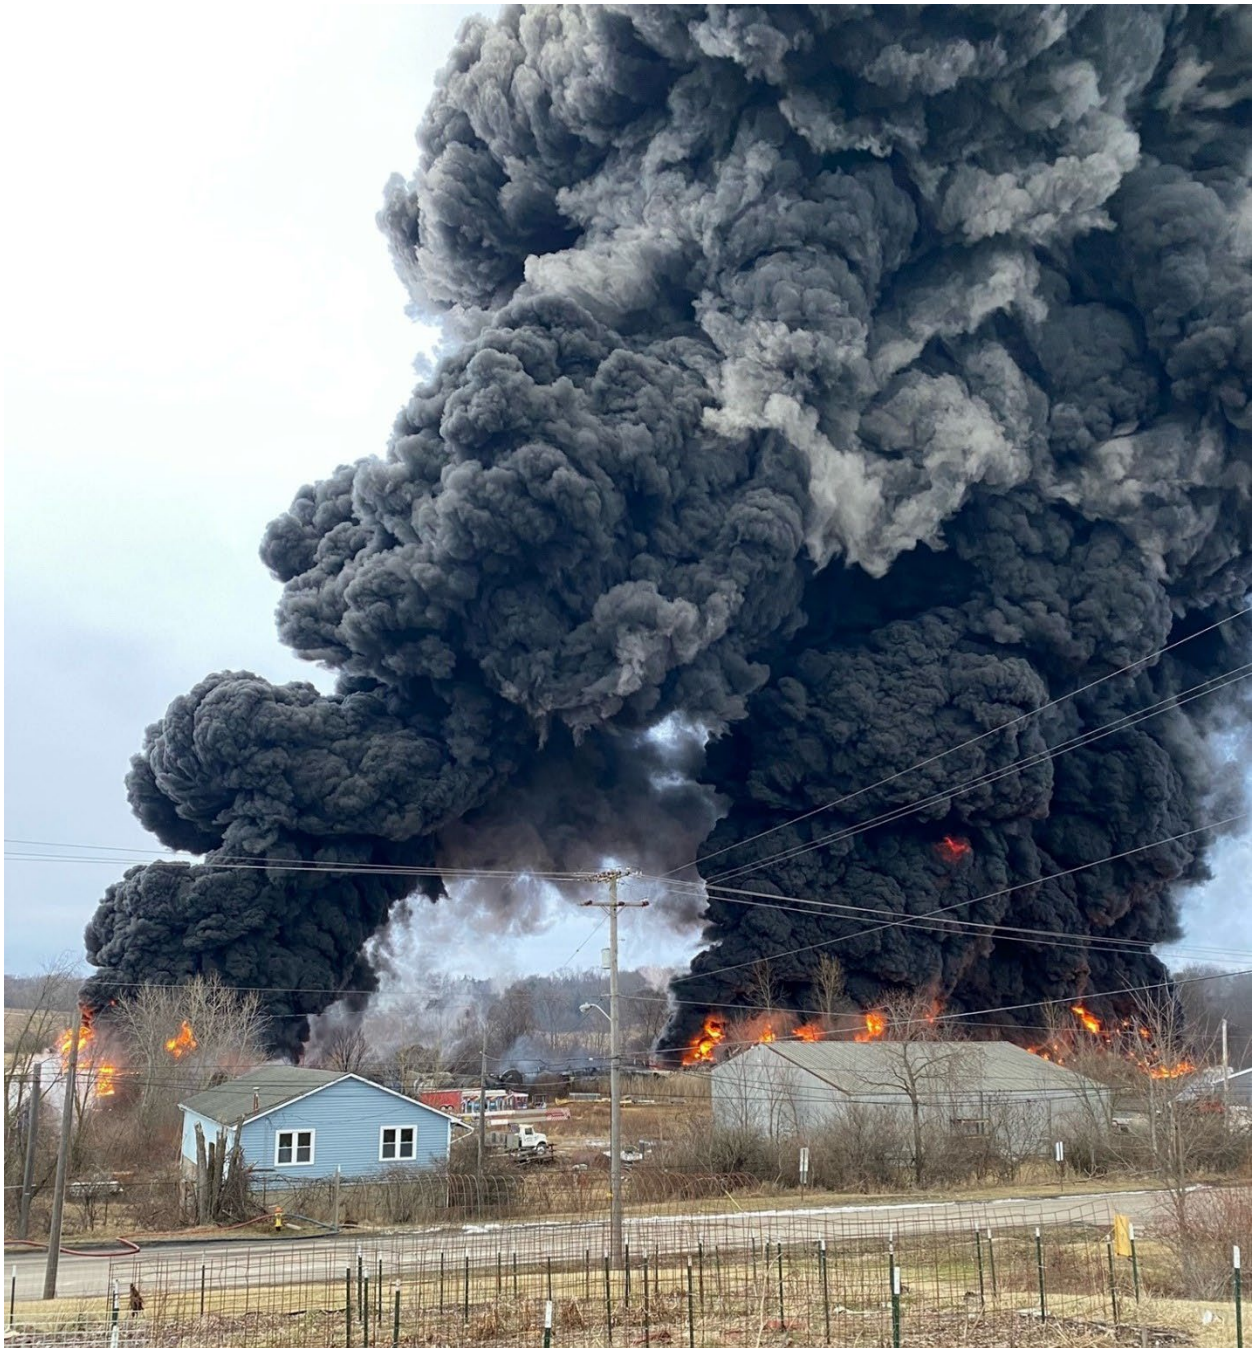
The vent and burn was originally scheduled for 1:00 p.m. on February 6, 2 hours ahead of the 3:00 p.m. deadline described to the incident commander by SPSI and SRS. However, the vent and burn was repeatedly delayed for technical and safety reasons: once to rewire the charges and three times because of unauthorized persons entering the evacuation zone. ESI detonated the vent and burn charges at 4:37 p.m. for all five VCM tank cars, puncturing each tank car at two points: the highest point in the vapor space and the lowest point where the liquid had pooled. The punctured tank cars expelled vapor, which was ignited by flares positioned near each tank car. Burning VCM resulted in a column of black smoke that grew into a persistent cloud. (See figure 10.) According to the NS system manager for hazardous materials, the cloud likely contained soot particles, carbon dioxide, carbon monoxide, hydrogen chloride, and a trace of phosgene (a toxic gas).

Figure 10. The vent and burn 3 minutes after detonation. (Courtesy of NS.)

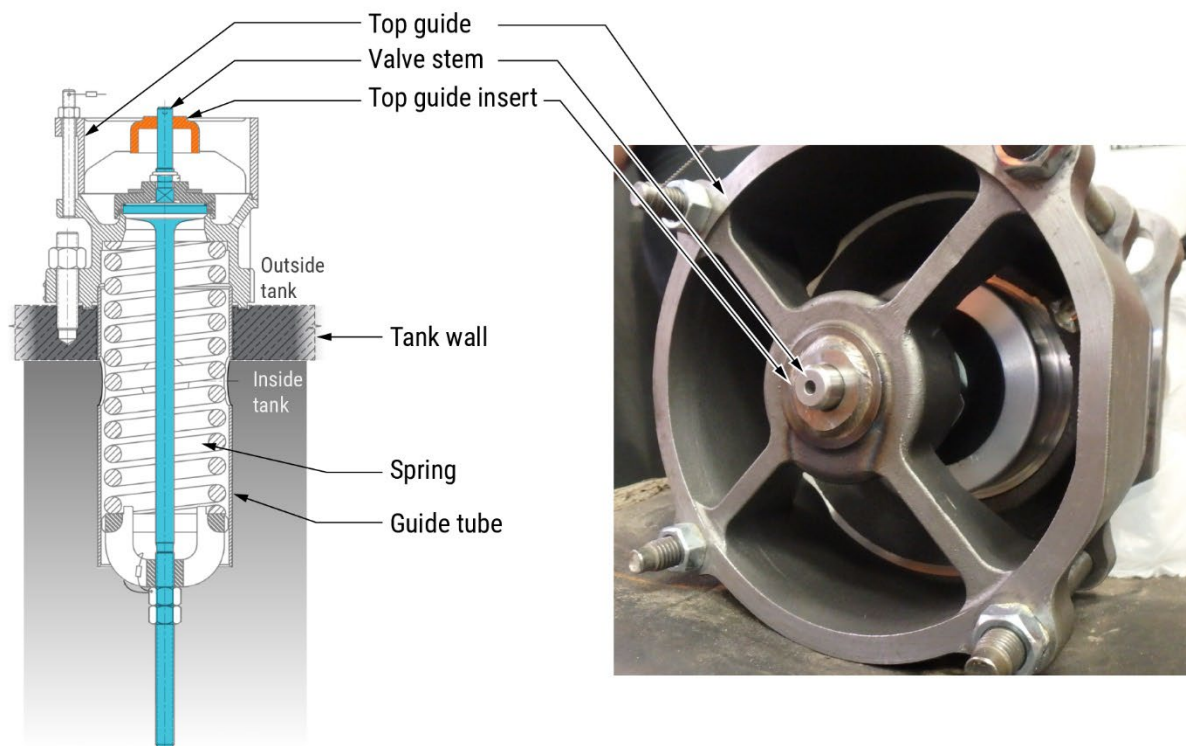
Figure 23. PRD diagram (left) and top-down view of exemplar (right). (Diagram courtesy of Midland Manufacturing with NTSB edits.)

The TILX402025 PRD top guide throat contained loose fragments of metallic debris. During testing, the PRD began to leak (release material without actuating) at 33.4 psig. According to its part specification, the spring was originally coated in aluminum. After bead blasting to remove carbon and soot, visual examination of the spring revealed that most of its aluminum coating was missing. The PRD did not contain any foreign matter obstructing its internal components.

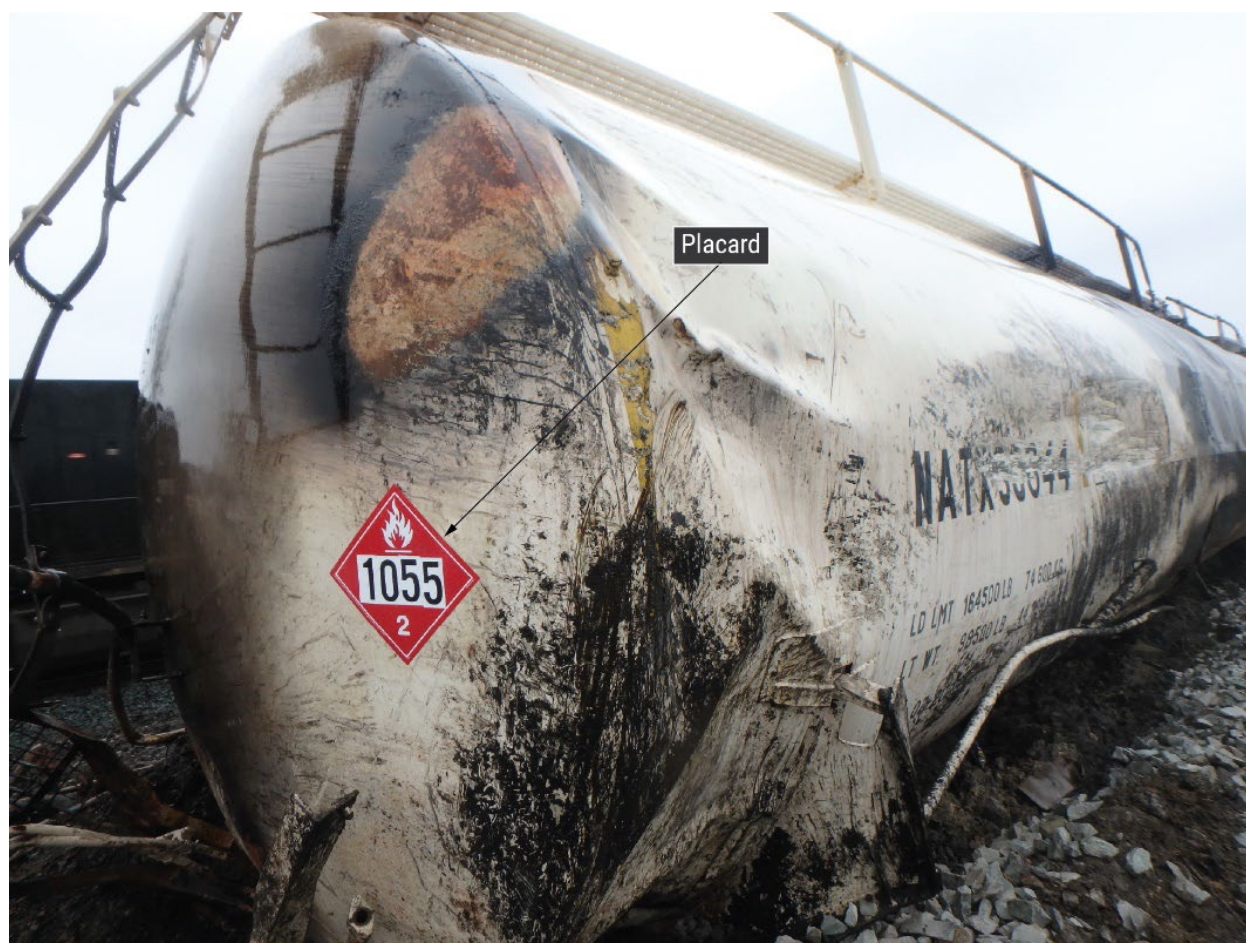
Federal regulations at 49 *CFR* Part 172 Subpart F establish requirements for placarding of hazardous materials offered for transportation. In general, a railcar containing any quantity of hazardous material must be placarded on each side and at each end in accordance with the naming conventions and placard design requirements set throughout the subpart. Figure 25 shows an example of an intact replacement placard affixed to a derailed tank car after fires were extinguished.

Figure 25. Replacement placard on a derailed DOT-105 tank car containing isobutylene.

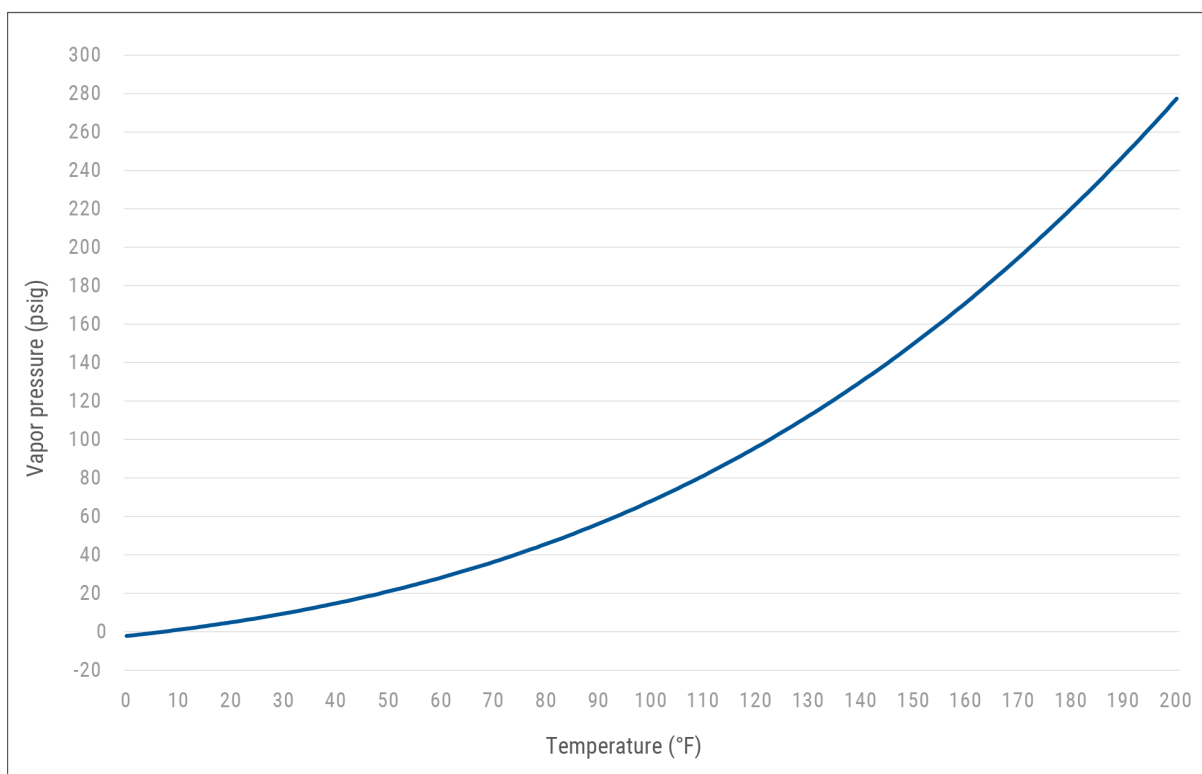
Figure 30. Graph of VCM vapor pressure by temperature.

The lowest start-to-discharge pressure identified during postaccident testing of a PRD known to actuate during fire exposure and then cease was 122 psig (OCPX80235). This pressure corresponds to a lading temperature of about 136°F. For OCPX80179, the start-to-discharge pressure identified during testing was 149.7 psig, which corresponds to a temperature of about 150°F. Typical measured temperatures for tank cars OCPX80235 and OCPX80179 ranged from 62 to 67°F. Similar analysis applies to the PRD with an elevated start-to-discharge pressure (from tank car OCPX80370). Given that this PRD would not start to discharge at 275 psig during testing, the lading temperature would have to exceed 199°F to actuate the PRD. The highest measured temperature for this tank car was 139°F, indicating a pressure of about 128 psig—much too low to overcome the stuck valve stem. Therefore, lading temperatures (and therefore internal tank pressures) are sufficient to explain the cessation of PRD activity even for PRDs with reduced start-to-discharge pressures, and PRD activity is not indicative of polymerization.

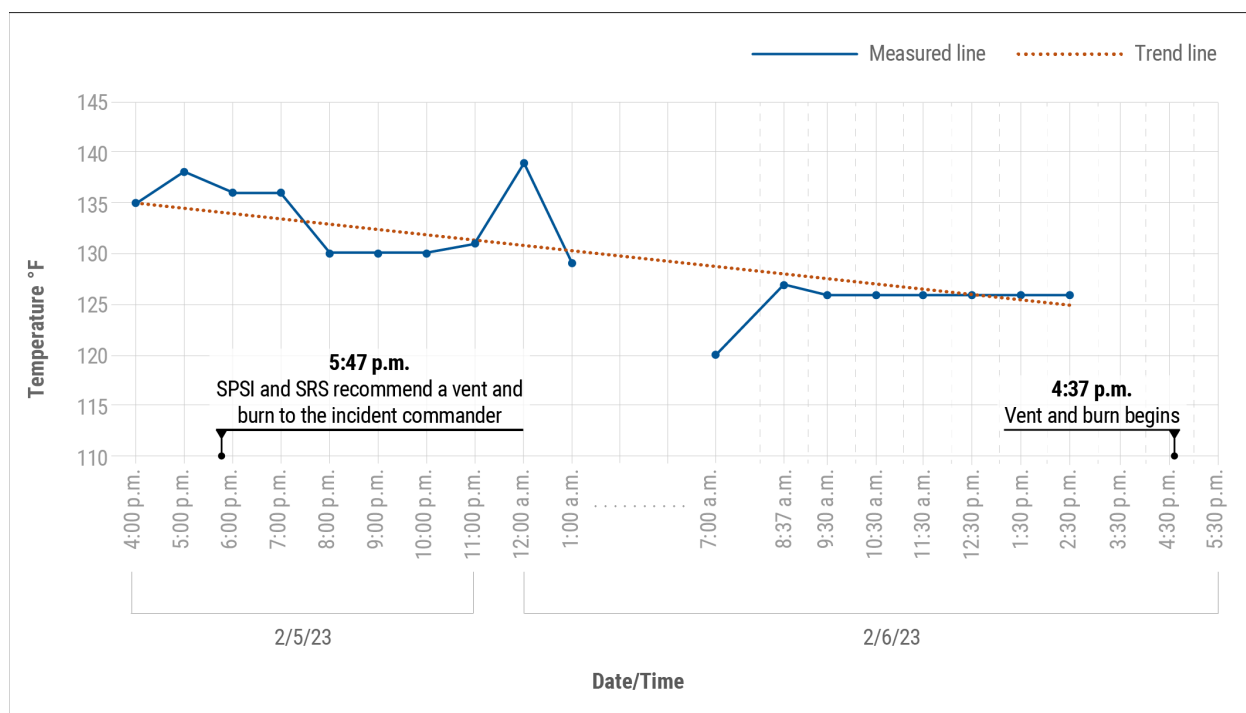
Despite this new information from Oxy Vinyls, NS and its contractors continued to respond to the situation as though the VCM was polymerizing. About 5:45 p.m. on February 5, 2023, after the meeting with Oxy Vinyls' on-scene representatives, SPSI and SRS contacted the incident commander and said that circumstances might require a vent and burn. This action demonstrated a focus on polymerization to the exclusion of alternatives even after Oxy Vinyls employees' initial judgment that polymerization was unlikely, and it ignored contradictory evidence: between 5:00 p.m. and 6:00 p.m., the measured temperature of the suspect tank car had fallen 2°F. The temperature continued to trend downward over the next day, as shown in figure 32. NS and its contractors continued to assert the necessity of a vent and burn when Oxy Vinyls' expert opinions and on-scene evidence should have led them to question their original focus on polymerization.

Figure 32. Tank car OCPX80370 temperature graph with vent and burn timing.

While NS and its contractors continued to advocate for a vent and burn, the on-scene Oxy Vinyls representatives conducted another conference call with the Oxy Vinyls team in Dallas. They reached a consensus that the available evidence did not indicate polymerization. By the time Oxy Vinyls met with SPSI at 7:00 p.m. on February 5, NS had begun preparations for the vent and burn. Oxy Vinyls shared its conclusions with SPSI, but SPSI did not reconsider its course of action, and neither SPSI nor NS shared Oxy Vinyls’ conclusions with the rest of the incident command. The NTSB concludes that NS and its contractors continued to assert the necessity of a vent and burn after expert opinion and available evidence should have led them to re-evaluate their initial conclusions regarding polymerization.
